OREGON DEPARTMENT OF TRANSPORTATION GRANTS PASS INTERCHANGE EXIT 58 ROAD SAFETY AUDIT

N. 6th Street at NW Morgan Lane Mile Point -2.54 to -2.36

January 2013

Grants Pass Interchange Exit 58 Road Safety Audit (RSA)

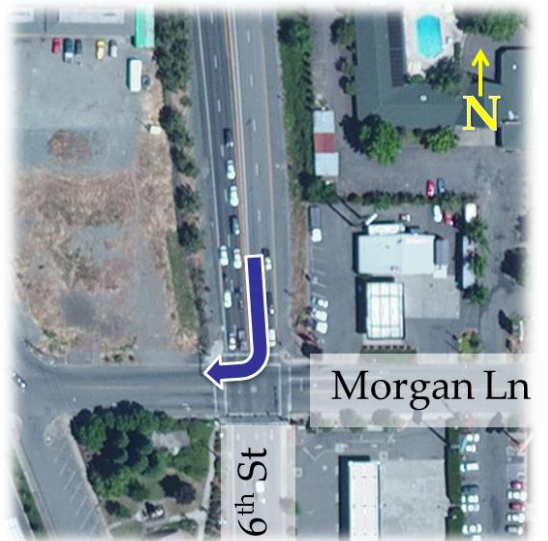
Exhibit 5 Scoville Road Southbound Right-Turn

In the six years of available data, 13 crashes were recorded between vehicles making the southbound right-turn from NE Scoville Road and vehicles making the southbound through movement from the I-5 southbound ramp. Seven (7) of these crashes were recorded in the three years between 2006 and 2008, and 6 of the crashes were recorded between 2009 and 2011. Four (4) of the crashes between the NE Scoville Road southbound right-turn and the I-5 southbound ramp through movement were recorded as injury crashes, all Injury C severity. The southbound right-turn movement from NE Scoville Road is a heavier movement than the southbound left-turn from the I-5 southbound ramp as described above, with 77 vehicles in the AM peak hour and 111 vehicles in the PM peak hour. The NE Scoville Road southbound right-turn movement is illustrated in Exhibit 4, Exhibit 5, and Exhibit 6 below.

- Unconventional intersection layout: the alignments of NE Scoville Road and the I-5 southbound ramp coming into the intersection with NW Morgan Lane in a parallel alignment creates the sense that the two approaches are one roadway, instead of two separate and conflicting legs of the intersection. The low, narrow curb separator between the two legs is also not effective in creating a sense of separation.

- Signal phasing: The approaches operate on a split phase arrangement as described above. The arrangement can create driver confusion when one approach starts and the other approach mistakes the green for their movement.

- Signal head alignment: The existing programmable signal heads on NE Scoville Road are clearly visible from the adjacent lanes at the stop bar on the I-5 southbound ramp. This creates the possibility for confusion of drivers not knowing which indication to obey.

- Conflicting movements in the same direction: Though the movements are separated with split signal phasing, the NE Scoville Road southbound right-turn is located to the left of the I-5 southbound ramp left-turn lane. This increases the potential for conflict and for collision between confused drivers.

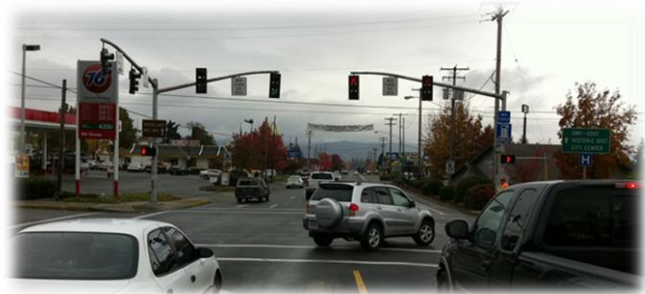
Exhibit 4 Scoville Road Southbound Right-Turn

- 8 of the 13 southbound right-turn crashes were recorded with the right-turning vehicle being at fault. These were primarily coded as “disregarded traffic signal” for the driver error.
- 5 of the 13 southbound right-turn crashes were recorded with the southbound through vehicle being at fault. These were primarily coded as “disregarded traffic signal” for the driver error.
- 1 of the 13 southbound right-turn crashes was a large semi-truck with trailers turning right at the signal and cutting the corner, colliding with a stopped vehicle.
- In 6 of the 13 southbound right-turn crashes, the offending vehicle was coded as a non-resident or as an Oregon resident from greater than 25 miles out of the area.

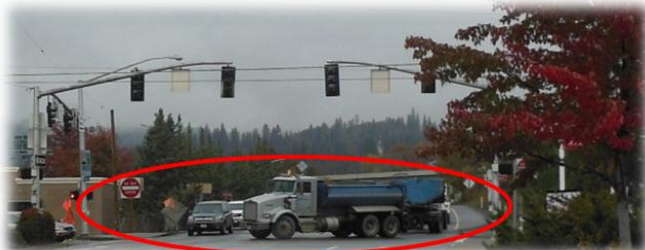
Exhibit 6 Truck Turn from Wrong Lane

- Trucks turning from the far lane: Several large trucks with trailers were observed turning right from the far left lane of NE Scoville Road to travel west on NW Morgan Lane. The maneuver is necessary to provide adequate turning radius for trucks to turn into the one receiving lane on NW Morgan Lane without conflicting with vehicles queued in the eastbound through lane. This maneuver creates the potential for crashes between the right-turning trucks and through vehicles in the inside lane of NE Scoville Road.

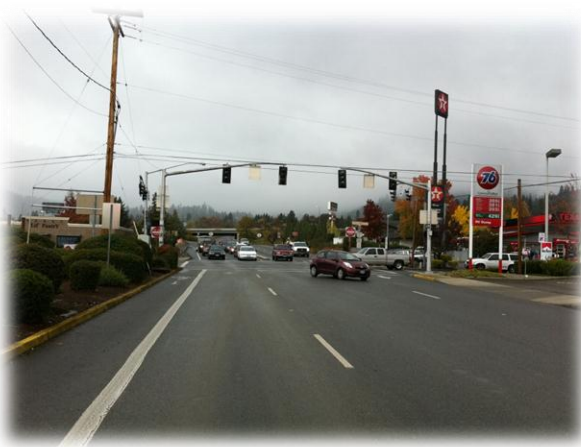
Exhibit 18 Eastbound right-turn off-tracking

- Of the 6 left-turn crashes, 1 was an Injury C crash. The rest were recorded as property damage only.
- Eastbound right-turns and westbound left-turns were observed to “off-track” into the center or far lane rather than the near lane. This may be due to the tight turning radius or destinations just downstream of the signal (i.e. gas stations, restaurants; see Exhibit 18 and Exhibit 19).

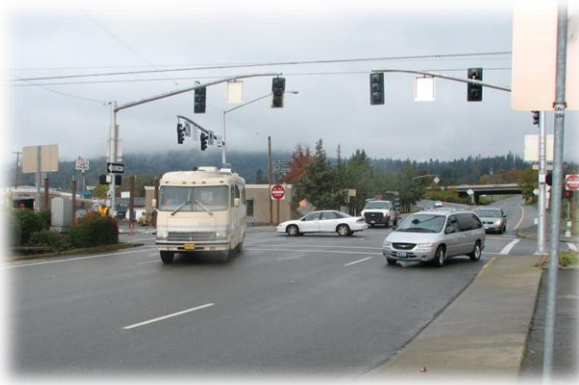
Exhibit 20 Simultaneous turns eastbound and westbound

- Many observations were made of eastbound right-turning vehicles and westbound left-turning vehicles completing their maneuvers simultaneously into the 3 receiving lanes on N 6th Street (see Exhibit 20).

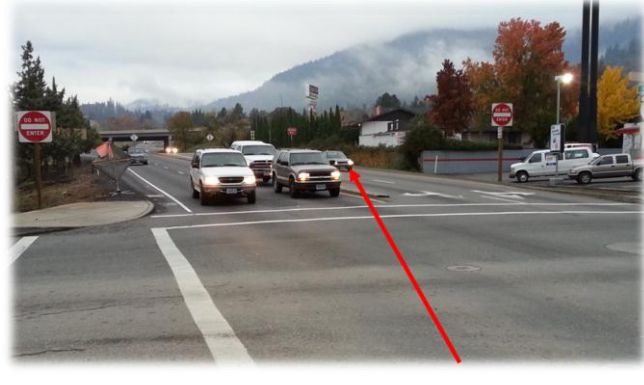
Exhibit 21 EB RT sight distance to Scoville Road SB

- Sight distance for the eastbound right-turn to see NE Scoville Road southbound through traffic is limited when vehicles are queued on the I-5 southbound off-ramp (see Exhibit 21).

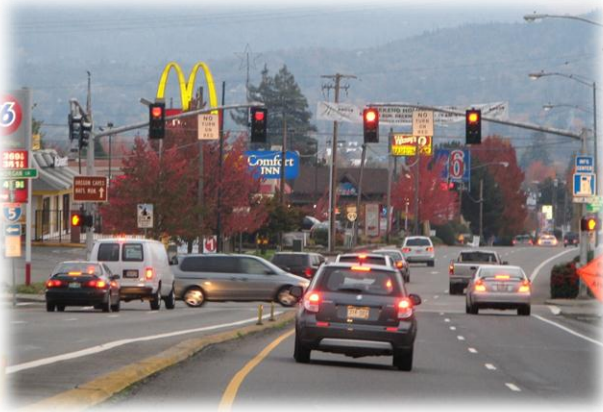
Exhibit 23 Signal Heads Visible from adjacent lanes/visual clutter

- Old programmable signal heads are visible from both roadway alignments and can be confusing to motorists in the adjacent lanes (see Exhibit 23 and Exhibit 24)
- Unconventional signal phasing – split phasing in the same direction
- Visual clutter – Commercial signing beyond the intersection creates background clutter and competes for attention with signal heads (see Exhibit 23 and Exhibit 25)
- The existing signal mast arms are “too busy” with signage and signal indications and may be structurally inadequate
- The signal heads installed for the I-5 southbound off-ramp are not centered over the approach lanes
- Eastbound and westbound NW Morgan Lane approaches have 8-inch existing signal lenses (see Exhibit 26)

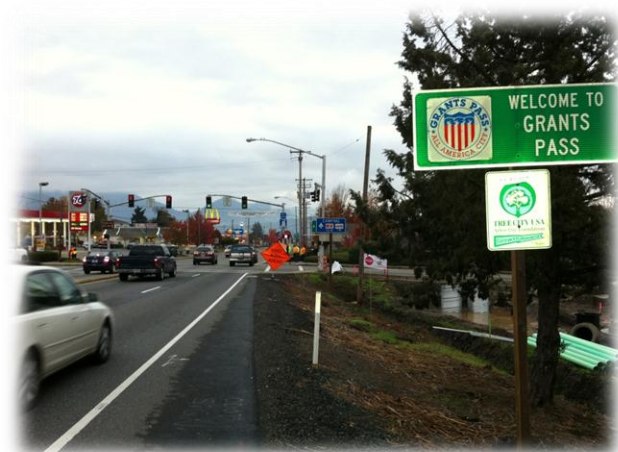
Exhibit 30 Sign clutter in advance of intersection

- Sign clutter in advance of intersection (see Exhibit 30 and Exhibit 31)
 - Too many signs, some blocking each other.
- Sign clutter on signal poles/mast arms (see Exhibit 32 and Exhibit 33)
 - Too many signs
- Driver overload – not enough time to process all the information

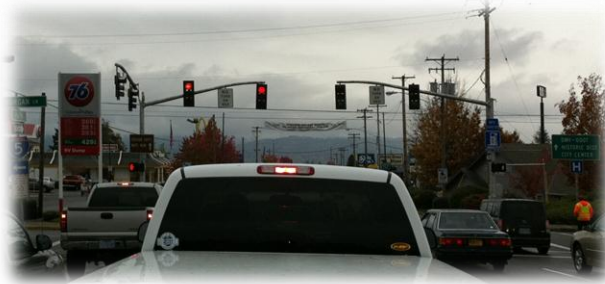
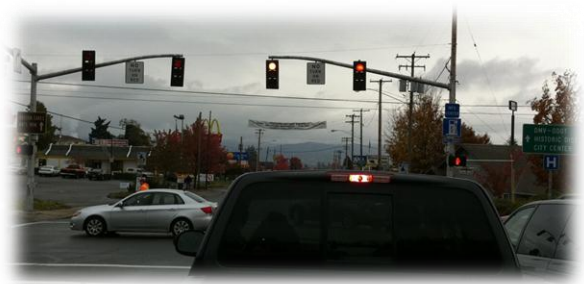
Exhibit 37 Configuration encountered by out-of-town drivers

- Approximately 60% to 65% of total crashes involve drivers that are non-residents or Oregon residents who live more than 25 miles away from the study intersection.
- Of the 32 southbound left-turn crashes identified as being the primary safety issue at the intersection, out-of-area drivers were at fault in 29 of the crashes.
- Out-of-area drivers may find the unconventional signal phasing and intersection configuration confusing or unexpected (see Exhibit 37).

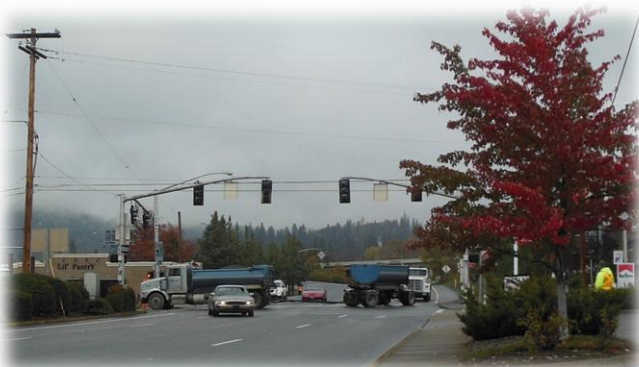
Exhibit 38 Large truck turning at intersection

- The RSA team observed a high volume of large semi-truck traffic through the intersection. Truck traffic seems to contribute to over 10% of the right-turn volumes and through movements.
- The intersection geometry (e.g. stop bar locations, curb radii, pole placement) does not accommodate large vehicles
- The existing signal poles at the intersection have been hit by trucks

- This presents a hazard to pedestrians in the vicinity of the pedestrian push-buttons.
- The team observed most trucks and even light pickup trucks have a difficult time turning into the near lane from NW Morgan Lane eastbound and westbound
- Trucks were observed turning right from NE Scoville Road and the I-5 exit ramp off-tracking into—or even turning from—the adjacent lane in order to properly align their vehicle into the receiving lane while avoiding the opposing lane of traffic.

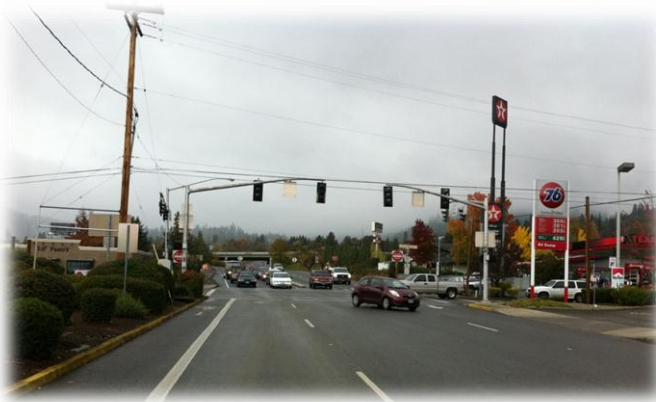
Exhibit 41 Vehicles weaving across N. 6th Street

- 76 gas station
 - Driveways immediately south of intersection.
 - Vehicles from eastbound NW Morgan Lane and southbound NE Scoville Road and I-5 southbound off-ramp weave across lanes to reach the driveways.
- McDonald's driveway
 - Used as a westbound alternative to NW Morgan Lane (cut through); 35 vehicles were observed during a 15-minute time period over the lunch hour.
 - Extends through from N 6th Street to N 7th Street and serves multiple land uses.
 - Vehicles weave across N 6th Street to reach the driveway.
