INTEROFFICE MEMO

SUBJECT: Rogue River TSP Technical Memorandum #4 Existing Conditions

The purpose of this memo is to update the existing conditions of Rogue River's Transportation System Plan. This will provide an overview of the current transportation system operations and deficiencies within the city.

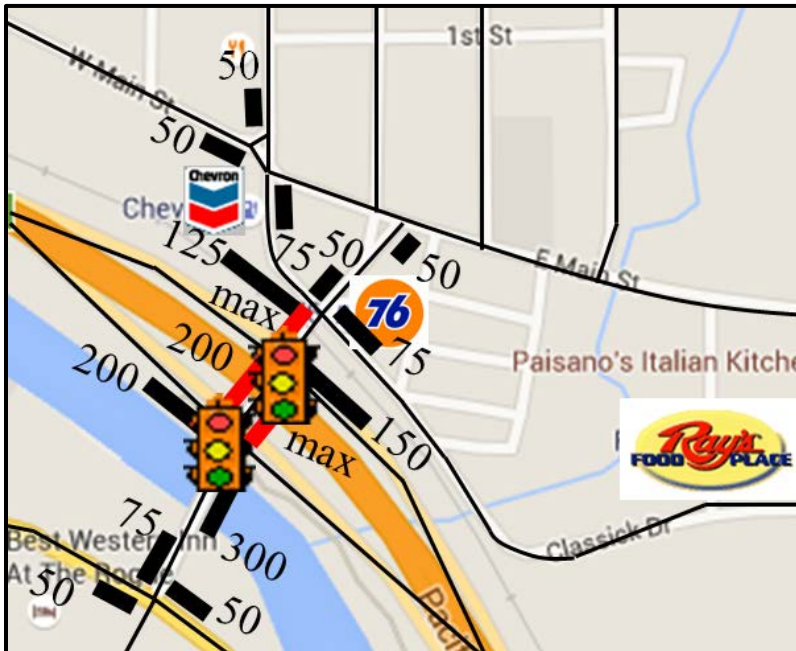
Figure 1: 95th Percentile Queues

The 95th percentile queue lengths showed no extensively long queues. The longest queues were along Depot Street in the interchange area as shown in Figure 1 as the queues extend between and through both ramp terminals which is a concern. Visual observation in the peak hour correlated well with the reported queues. The reported distance of 325 feet could represent thirteen cars. There are five closely spaced public

intersections on Depot Street (OR99, SB interchange ramp terminal, NB interchange ramp terminal, Pine Street, and East Main Street). The spacing of these streets as well as alleys and the railroad crossing creates areas where driver decision points and turn movement conflicts overlap.

The intersection of Depot Street at Pine Street is a concern as it is less than 150 feet north of the NB I5 intersection with railroad tracks in between. This results in virtually no space to store vehicles waiting at the NB ramp terminal intersection. One short vehicle can fit between the intersection stop-bar and the railroad tracks and the rest have to queue on the eastbound Pine Street, southbound Depot Street or westbound Classick Drive approaches.
