INTEROFFICE MEMO

**Department of Transportation
Transportation Development Division**

**SUBJECT: UPDATED: Rogue River TSP Technical Memorandum #4 Existing
Conditions**

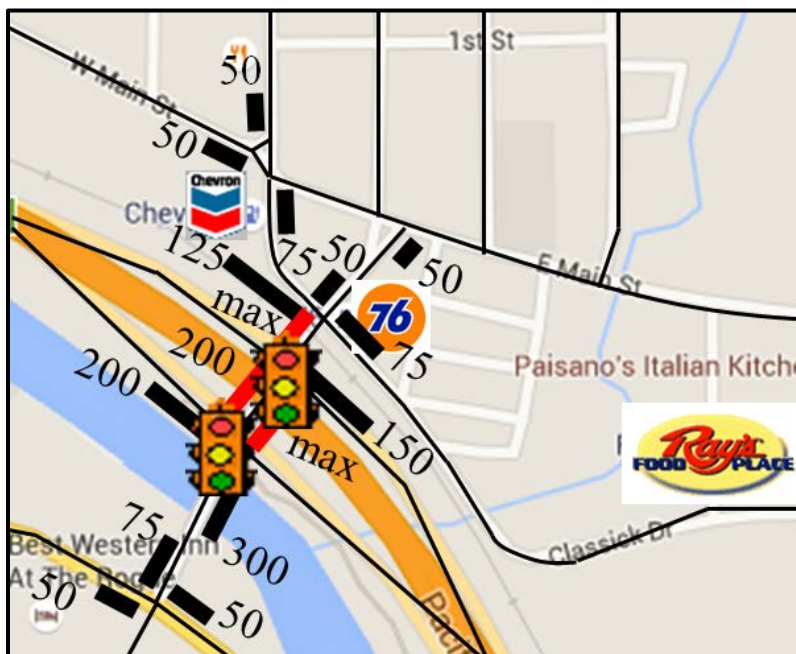
Figure 1: 95th Percentile Queues

The 95th percentile queue lengths showed no extensively long queues. The longest queues were along Depot Street in the interchange area as shown in Figure 1 as the queues extend between and through both ramp terminals which is a concern. Visual

observation in the peak hour correlated well with the reported queues. The reported distance of 325 feet could represent thirteen cars. There are five closely spaced public intersections on Depot Street (OR99, SB interchange ramp terminal, NB interchange ramp terminal, Pine Street, and East Main Street). The spacing of these streets as well as alleys and the railroad crossing creates areas where driver decision points and turn movement conflicts overlap.

The intersection of Depot Street at Pine Street is a concern as it is less than 150 feet north of the NB I5 intersection with railroad tracks in between. This results in virtually no space to store vehicles waiting at the NB ramp terminal intersection. One short vehicle can fit between the intersection stop-bar and the railroad tracks and the rest have to queue on the eastbound Pine Street, southbound Depot Street or westbound Classick Drive approaches.

The constrained interchange section also can cause a number of operational issues. Any kind of incident on Depot Street or even when a train is crossing can quickly create congestion which can back onto the ramps and out onto the I5 mainline. Queuing that extends out onto the deceleration portion of the ramp or out onto the mainline is an inherent safety issue. The southbound off-ramp is likely to have this problem more often than in the northbound direction. Also, the geometry of the southbound ramp terminal intersection is tight enough that trucks trying to turn left to go into downtown can interfere with vehicles waiting in the left turn lane to head south on I5.
