Department of Transportation Transportation Development Division

SUBJECT: UPDATED: Rogue River TSP Technical Memorandum #6 Deficiencies

This memo summarizes Rogue River's transportation system deficiencies gathered from the previous technical memorandums and other sources. This analysis includes an evaluation of the study intersections for transportation system issues for motorized and non-motorized travel modes. This memorandum was updated to include pedestrian and bicycle issues on OR99.

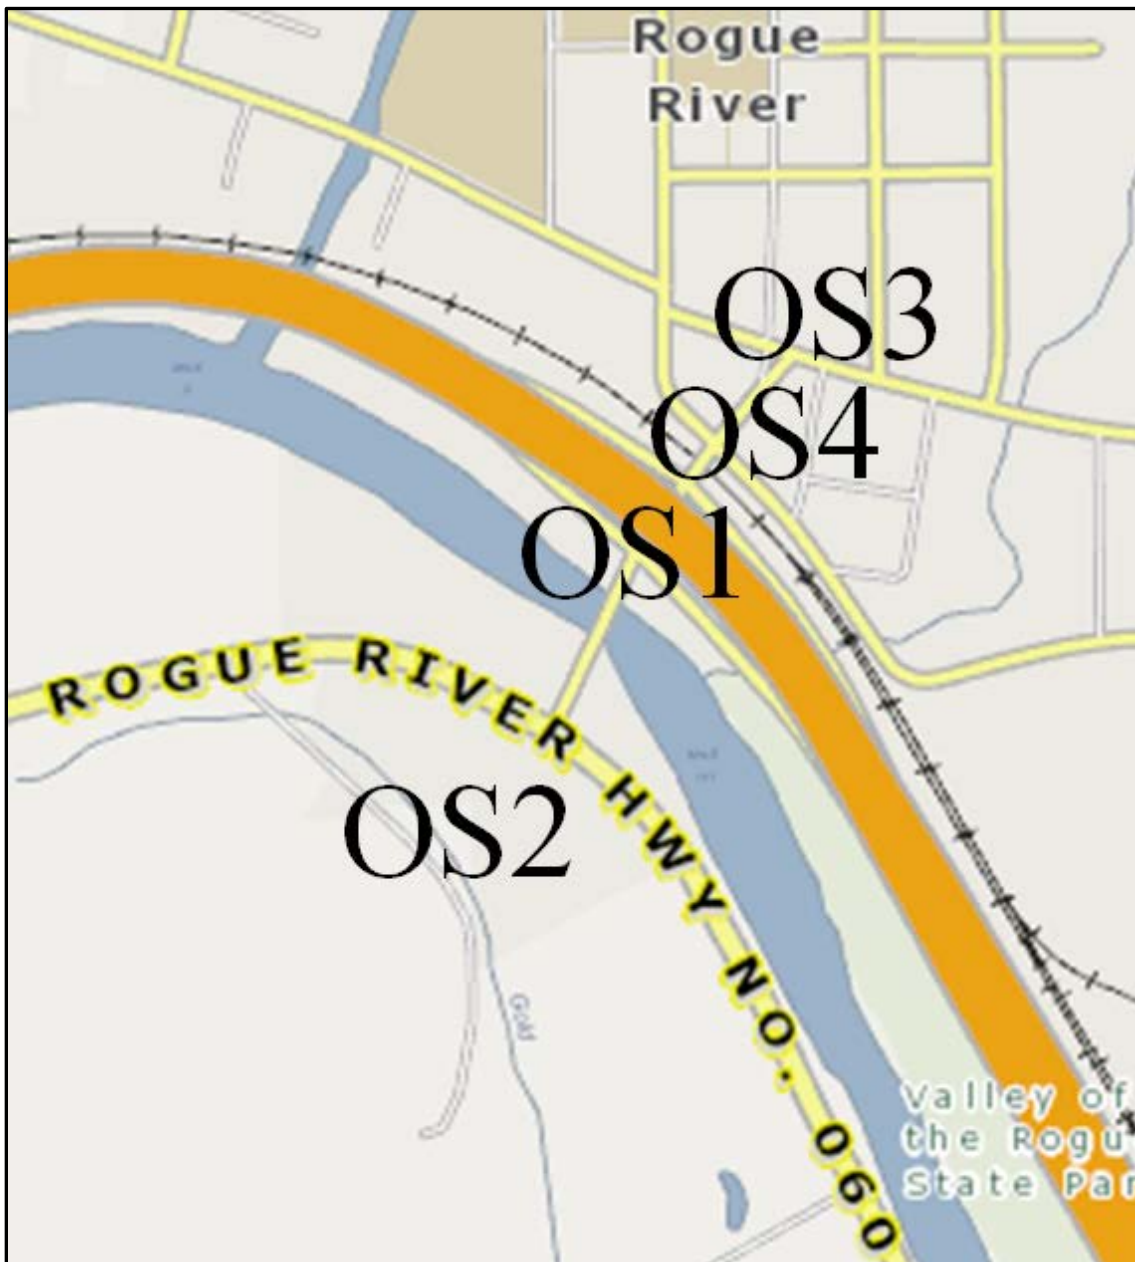
OS1 Ramp Terminal Queuing

The constrained I-5 & Depot Street ramp terminals and the overall interchange section create a number of safety issues. The overall lack of maneuvering room and queue storage leads to congestion even at relatively low volumes, creating serious queuing issues. Any incident or slowdown on Depot Street or a train crossing can quickly create queues back onto the ramps and even onto I-5 mainline. Queuing that extends into the deceleration portion of the ramp or onto I-5 mainline is an inherent safety issue. The southbound off-ramp will start having this problem by 2024. The predicted queue of 400 feet in 2040 will extend well into the deceleration zone. Drivers will need to brake much earlier than expected to avoid potential collisions. This safety issue is worsened with the curves that precede the southbound off ramp.

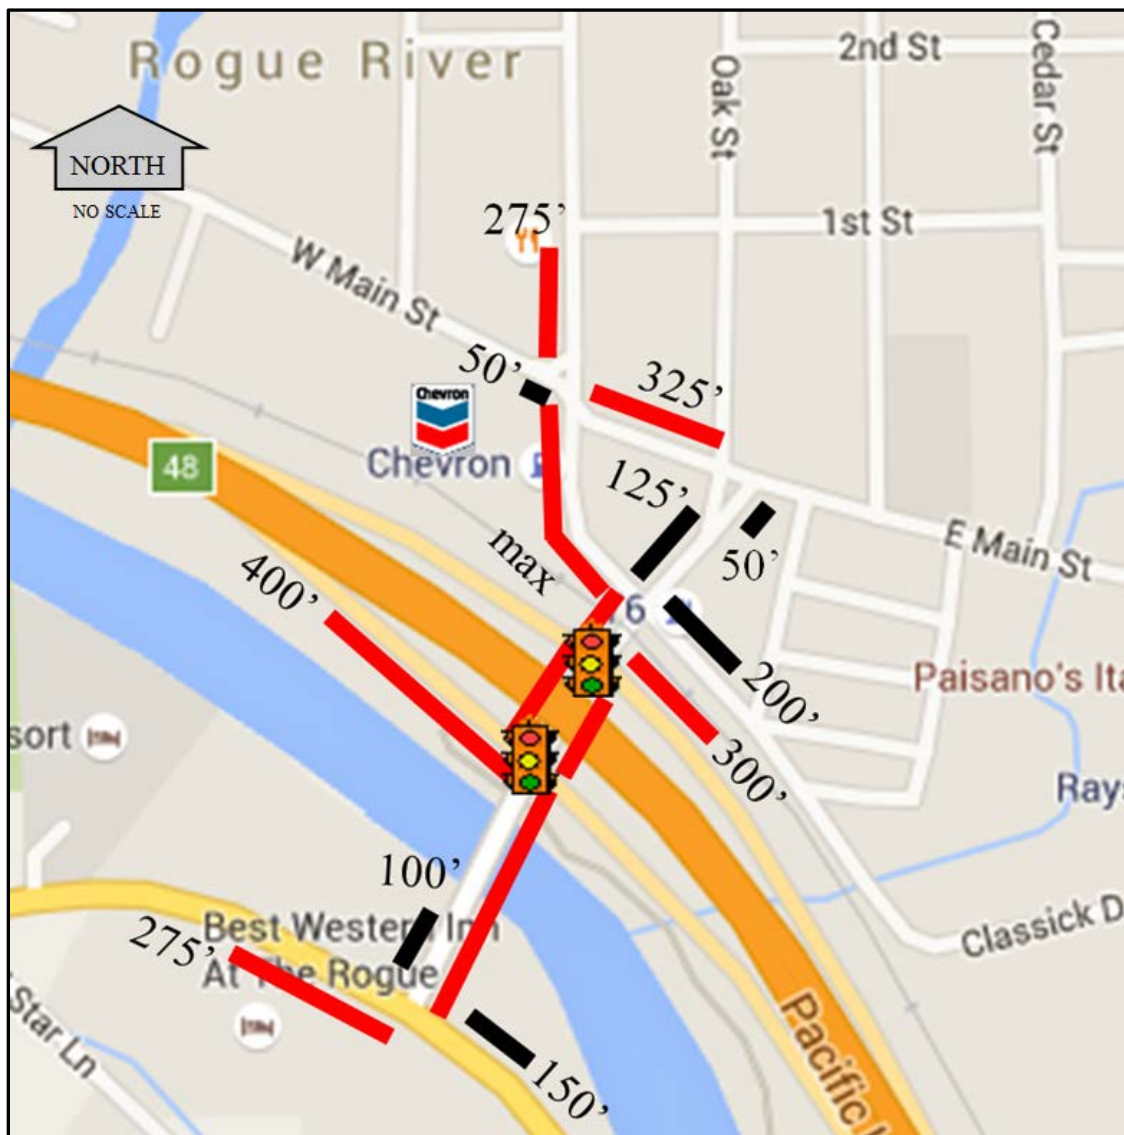
OS2 Depot Street and OR 99

The V/C at this intersection is forecasted to be 0.63 in 2040. This intersection will have a significant southeast bound left turning queue on OR99 that may not be expected by southbound drivers. This may lead to an increased amount of rear-end collisions. Vehicles waiting to turn will not have anywhere to go as there will be queues propagating back from the interchange. The ADT/C ratio is 6.31, uncongested with no slowing speeds.

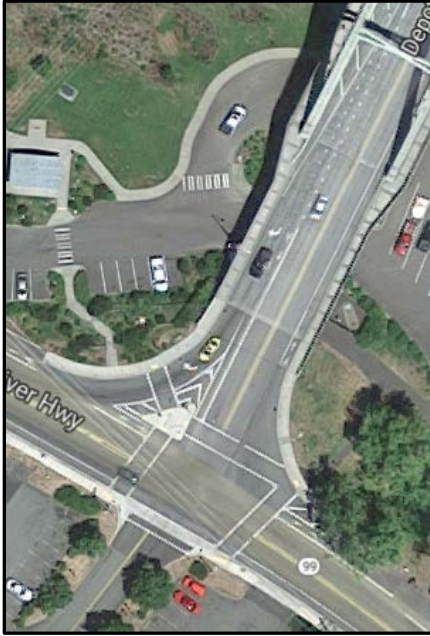
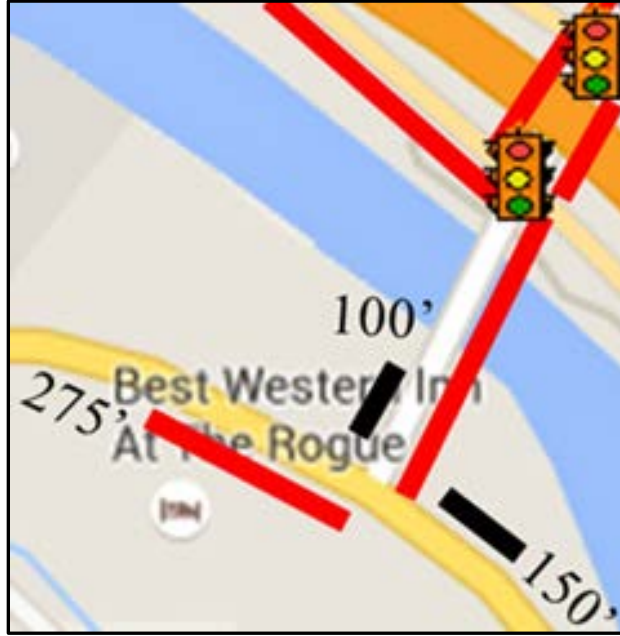
OS3 Depot Street and Main Street

The v/c at Depot and Main Street is forecasted to be 0.36 in 2040. Intersection operation will likely be affected by queuing extending from the adjacent Main & Pine Street and Pine & Depot Street intersections. The ADT/C ratio is 10.76, congested with slowing speeds on a daily basis. The overall capacity here is low as the intersection is in a non-standard configuration; however Preliminary Signal Warrants (PSW's) were not met. The alignment of this intersection should be investigated. As configured, the northbound movement is indirect and goes through two closely spaced intersections. Both intersection functional areas overlap, leading to increased chance of conflicts, collisions, and pedestrian crash. Drivers too-focused on maneuvering through the intersection might not see a pedestrian.

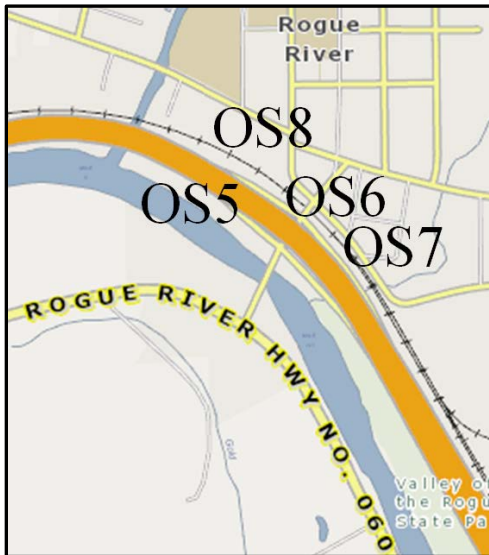
OS5 Depot Street and SB I-5

The V/C at this intersection is forecasted to be 1.07 in 2040 and over capacity. This intersection is predicted to exceed the standard of 0.85 in 2028. This intersection is forecasted to be at capacity ($V/C = 1.00$) in 2036. This signalized intersection will have queues in both directions on Depot Street radiating from the closely spaced nearby intersections. These queues are evident under existing conditions and will get worse. There will be an unreasonable delay due to queuing on all legs, especially on the exit ramp. The ADT/C ratio is 10.36, congested with slowing speeds on a daily basis. As can be seen by the red lines on the queuing diagram, queues will extend through the interchange and up the ramp.

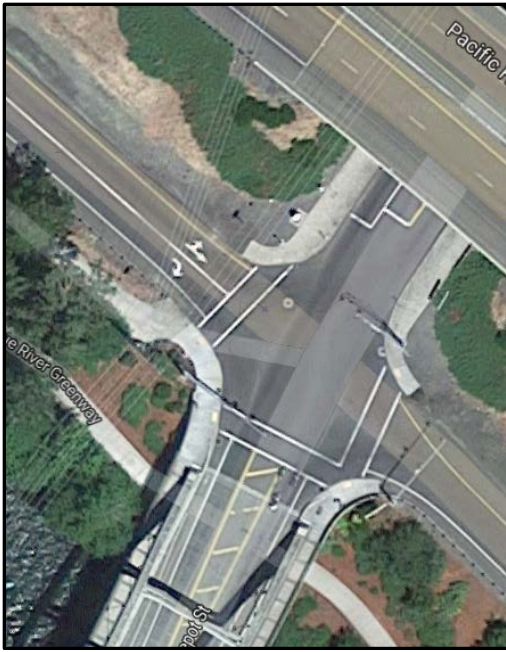
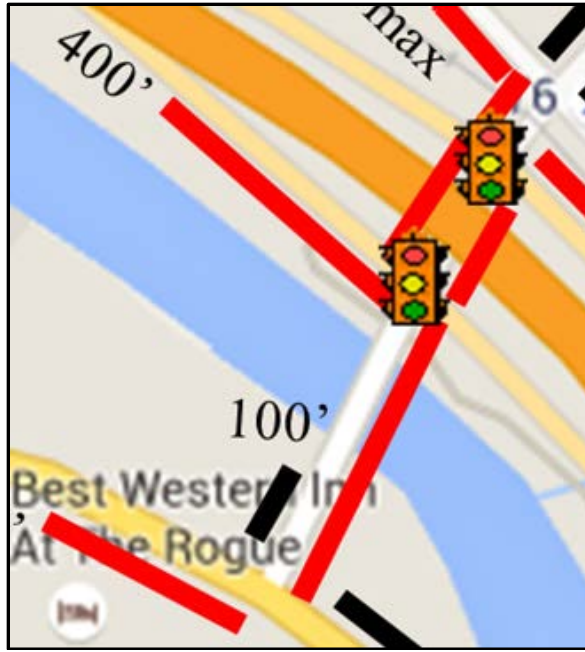
OS6 Depot Street and Pine Street

The V/C at Depot Street and Pine Street is forecasted to be 1.10 in 2040. This intersection is predicted to exceed the standard of 0.95 in 2038. This intersection is forecasted to be at capacity ($V/C = 1.00$) in 2039. Due to queues and delay, this intersection will not work in its current control and form in the future. Even with the high v/c ratio, this intersection does not meet preliminary signal warrants (PSW), but even if it did, intersection spacing and lack of queue storage space is too limiting for good operation. There will be an unreasonable delay by all three stopped approaches, especially Classick Dr. The ADT/C ratio is 7.01, not hugely congested on a daily basis. The intersection diagram below shows a lack of capacity available for the Pine and Classick movements.

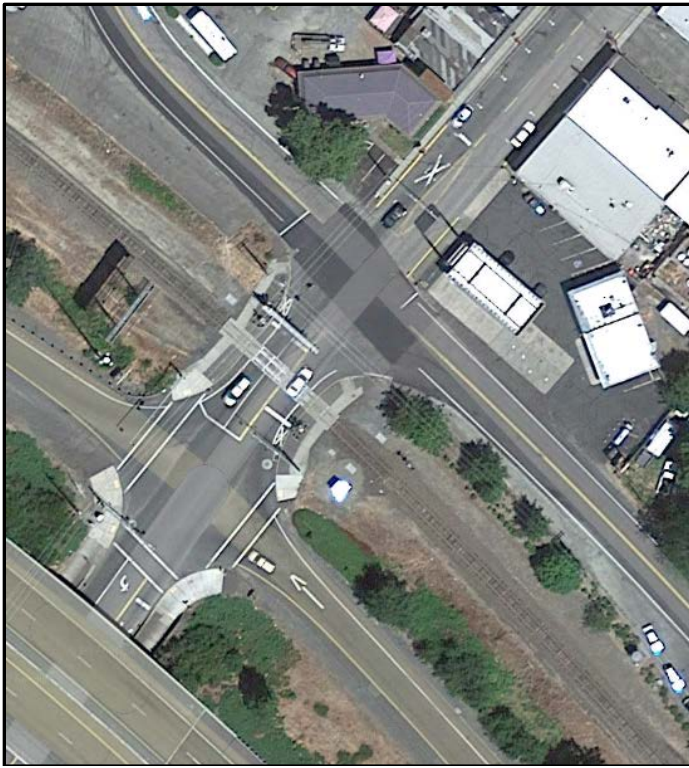
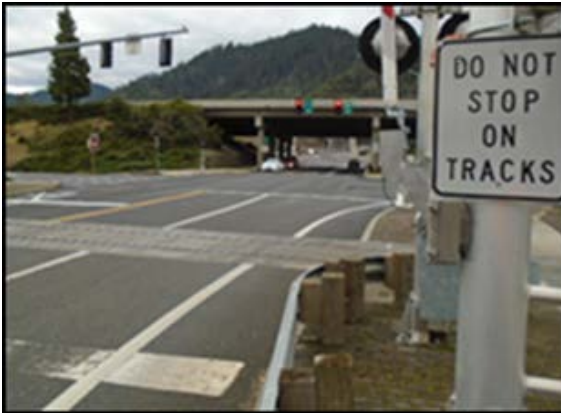
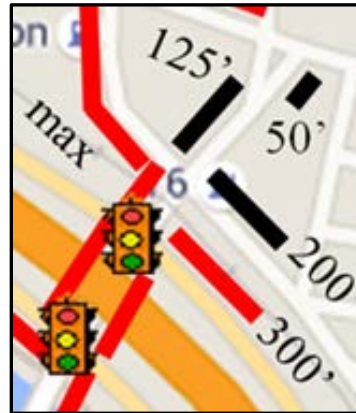
OS7 Depot Street and NB I-5

The Depot and Pine Street intersection has a lack of queuing space on the south leg due to a railroad crossing seen in the photograph below. This issue leads to a lack of queuing space on the north leg of the adjacent intersection, the I-5 ramp terminal. Both the Rogue Valley Commuter line transit operation and the City fire department have noted a lack of space to wait for the northbound I-5 ramp terminal intersection signal and not sit on the railroad tracks, which is a challenge for longer vehicles. The police department also mentions it as a general concern. On the queuing diagram below, there are queues that extend from the interchange upstream into this intersection and the Pine & Main Street intersection. In 2028 the eastbound queue of Depot and Pine Street will be long enough to interfere and interrupt operations at Pine and Main Street. This is a problem that needs to be addressed.

The V/C at this intersection is forecasted to 1.07 in 2040, over capacity. This intersection is predicted to exceed the standard of 0.85 in 2028. This intersection is forecasted to be at capacity (V/C = 1.00) in 2036. This signalized intersection will have queues in both directions on Depot Street radiating from the closely spaced nearby intersections. These queues are evident today under existing conditions and will get worse in the future.

There will be an unreasonable delay and queues on all legs, especially the exit ramp. The ADT/C ratio is 11.06, congested with slowing speeds on a daily basis. As seen in the photo, there is not queuing space for large southwest bound vehicles on Depot Street heading toward southbound I-5 or OR99. As can be seen by the red lines on the queuing diagram, there are queues that extend through the interchange and up the ramp.

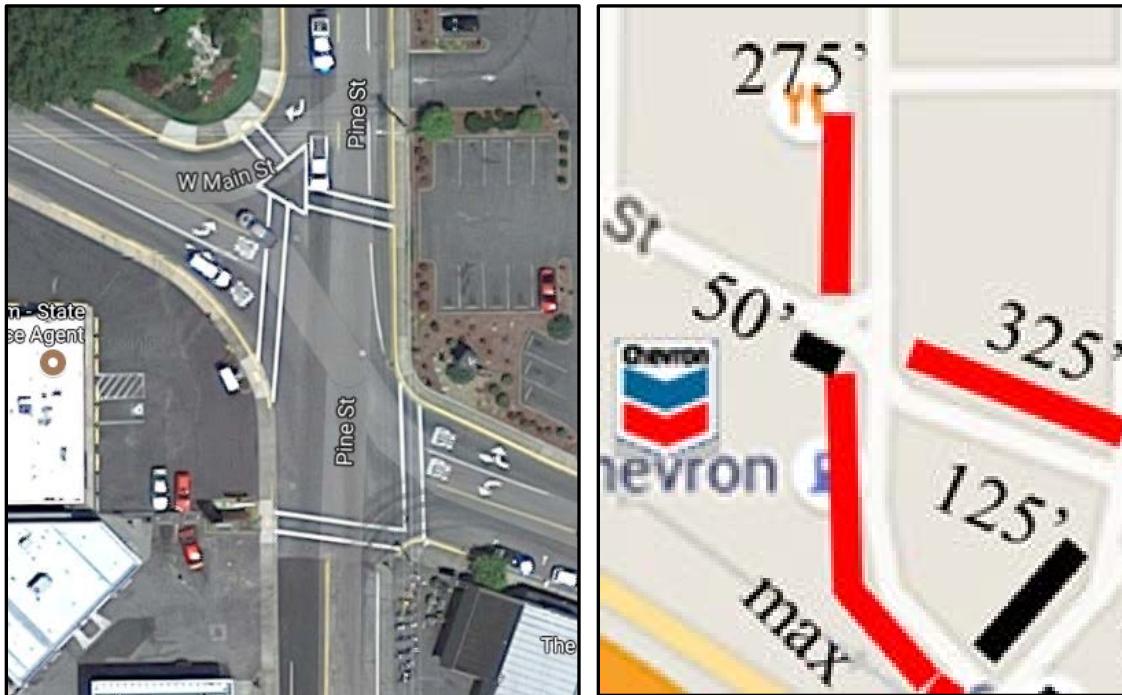
By 2040, the westbound queue on Main Street will extend to and interfere with operations at Depot and East Main Street.

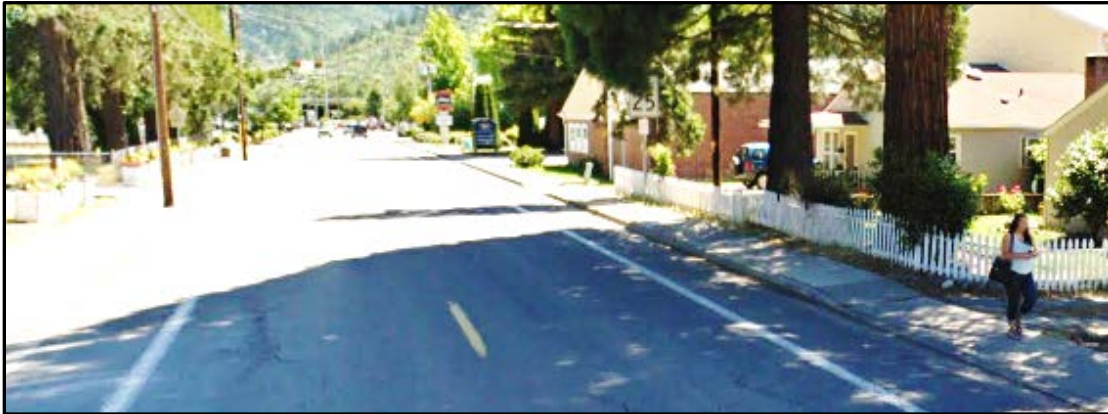
B2 East Evans Creek Road

The paved shoulder on East Evans Creek Road and past the high school is only about four feet wide in most places, and while potentially inviting, it is functionally too narrow for safe bicycle riding and has a LTS 4 rating as a result.

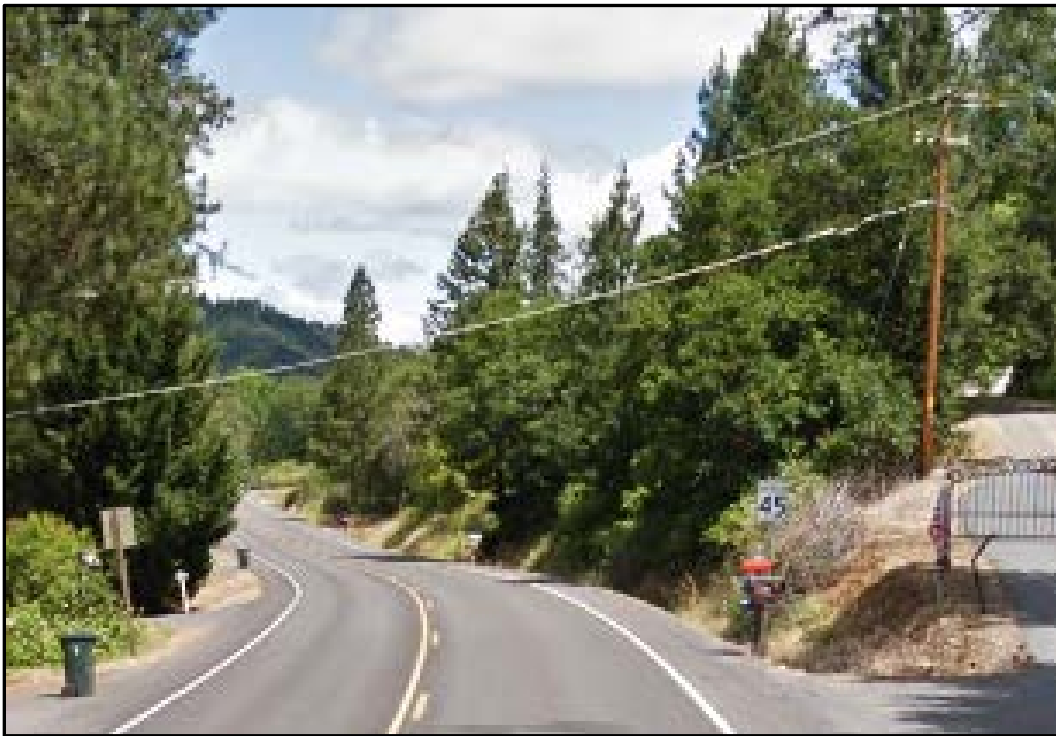
B3 West Main Street

West Main Street has paved shoulders that could be used as bicycle facilities, although it is too narrow. In some locations east of East Evans Creek Road, there is no sidewalk and a section of the pavement is striped to substitute for a combination walking path/possible bike lane.

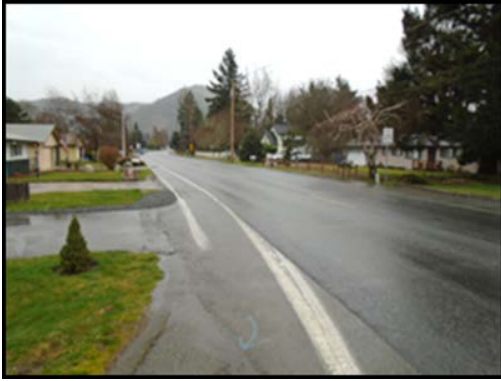
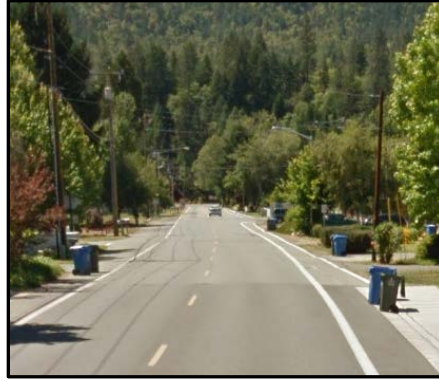
B4 East Main Street

East Main Street needs to show shared path markings for vehicles and bicycles from Ward Creek west. East Main Street east of Ward Creek has a wider shoulder on the north side to Wards Creek Road that could be converted into a four to six foot bicycle lane.

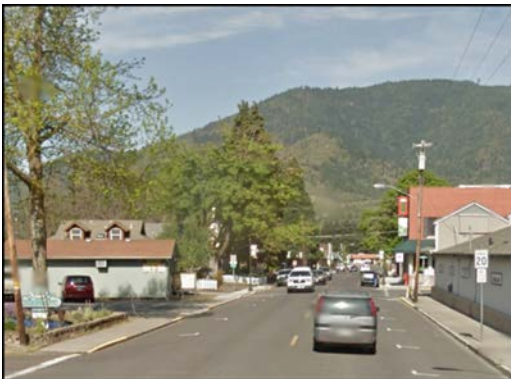
B5 Broadway Street North

Broadway St north of 1st Street needs to have bicycle lanes

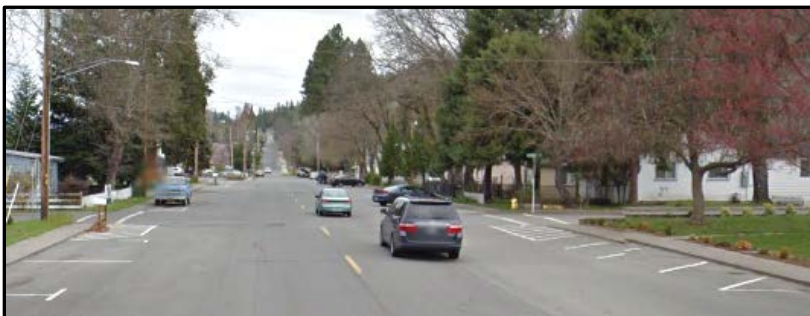
B6 Broadway Street South

Broadway St south of 1st Street needs to have bicycle lanes on both sides of the street and is a LTS 3 section.

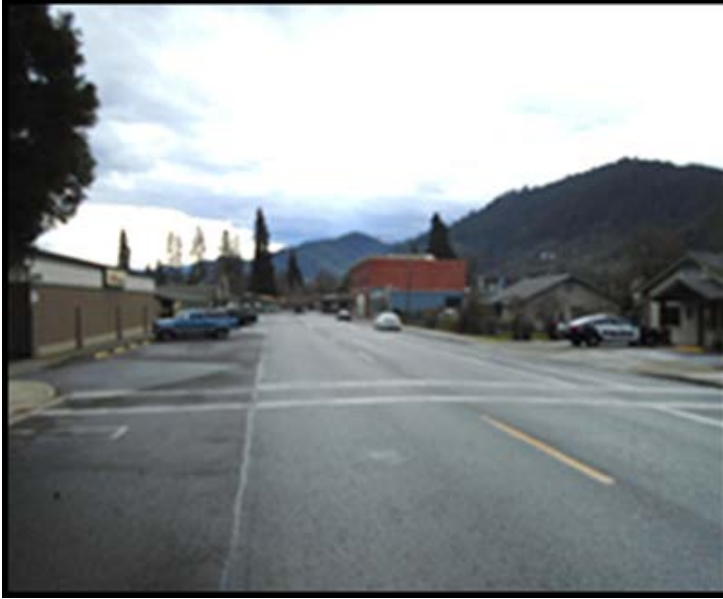
B7 N River Rd

North River Road south of Classick Drive could use bicycle lanes given the auto speed limit in this LTS 3 section instead of a wider paved shoulder that allows for parking that is not necessary. It would be good to connect the Mountain of the Rogue Mt Bike trail and invite those that use this recreational facility to come into town on a bicycle.

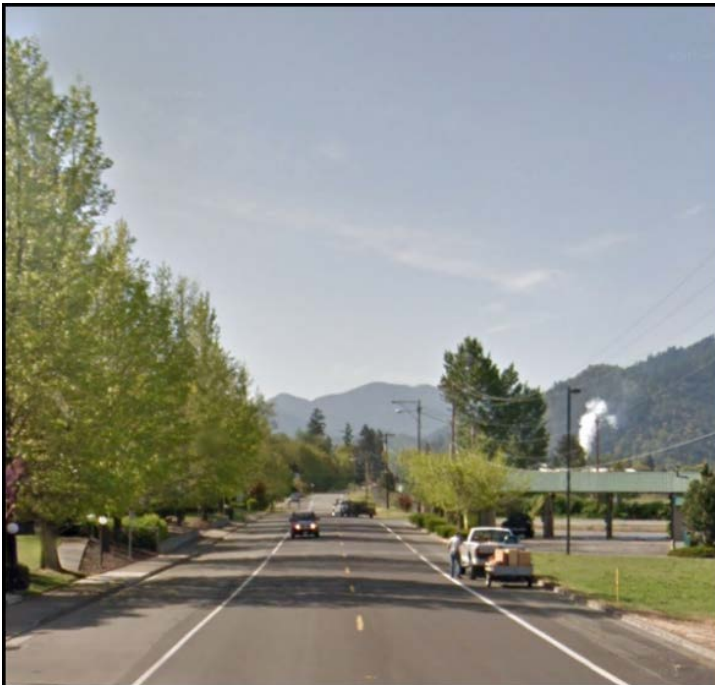
Vehicle in shoulder

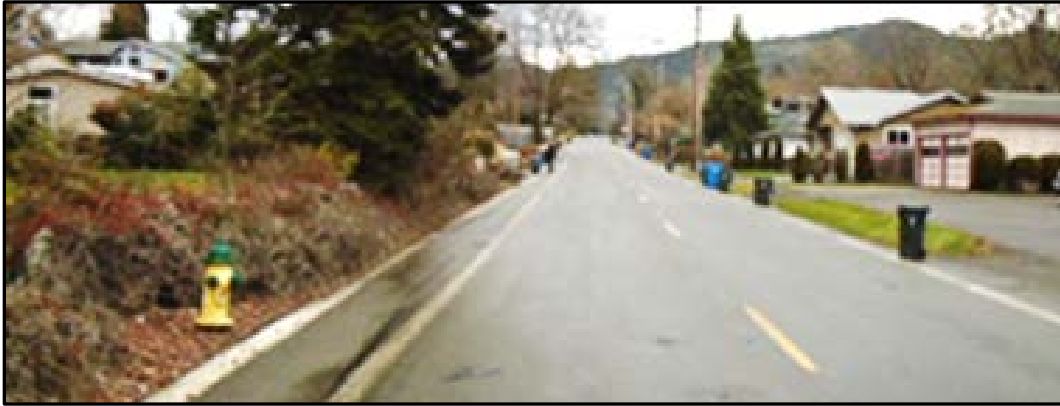
B9 OR99

With the high volume of vehicles using OR99, there should be improved bicycle facilities. The bicyclists need to feel safe in this public environment. This should be on both sides of OR99 within the Urban Growth Boundary of Rogue River.

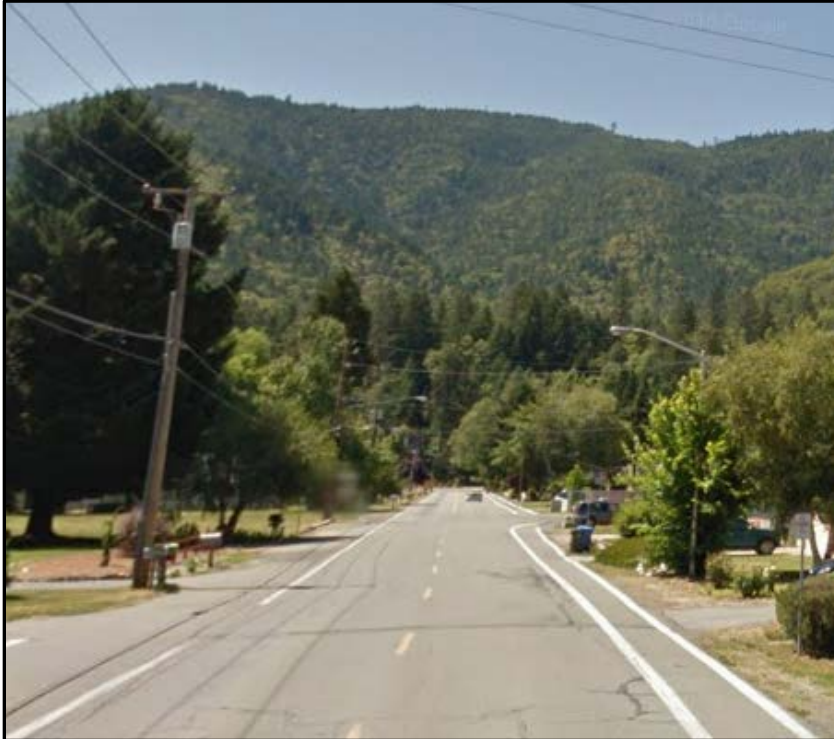
P2 East Main Street

East Main Street needs sidewalk facilities on the south side from Rogue Lane to N River Road.

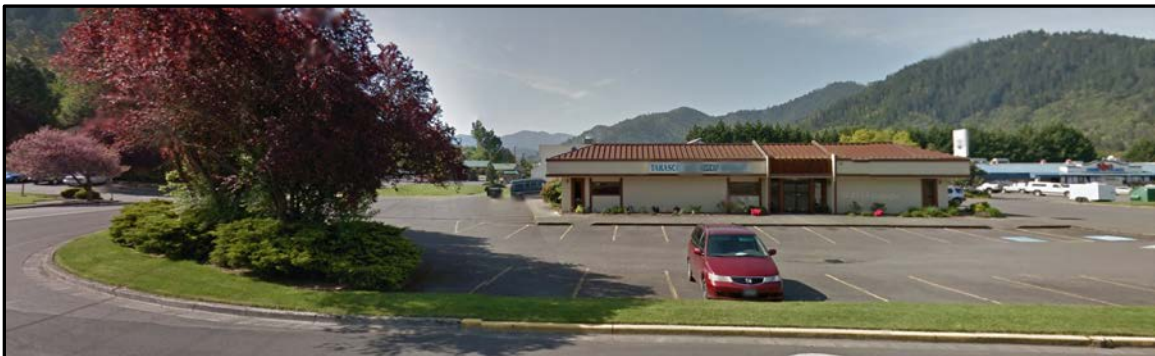
P3 Pine Street/E Evans

From Short Street north, sidewalk only exists on the west side of Pine Street for a short distance. From Creek View Lane north, there are no sidewalk facilities on Pine Street/ East Evans Creek Road, access to the middle school and high school.

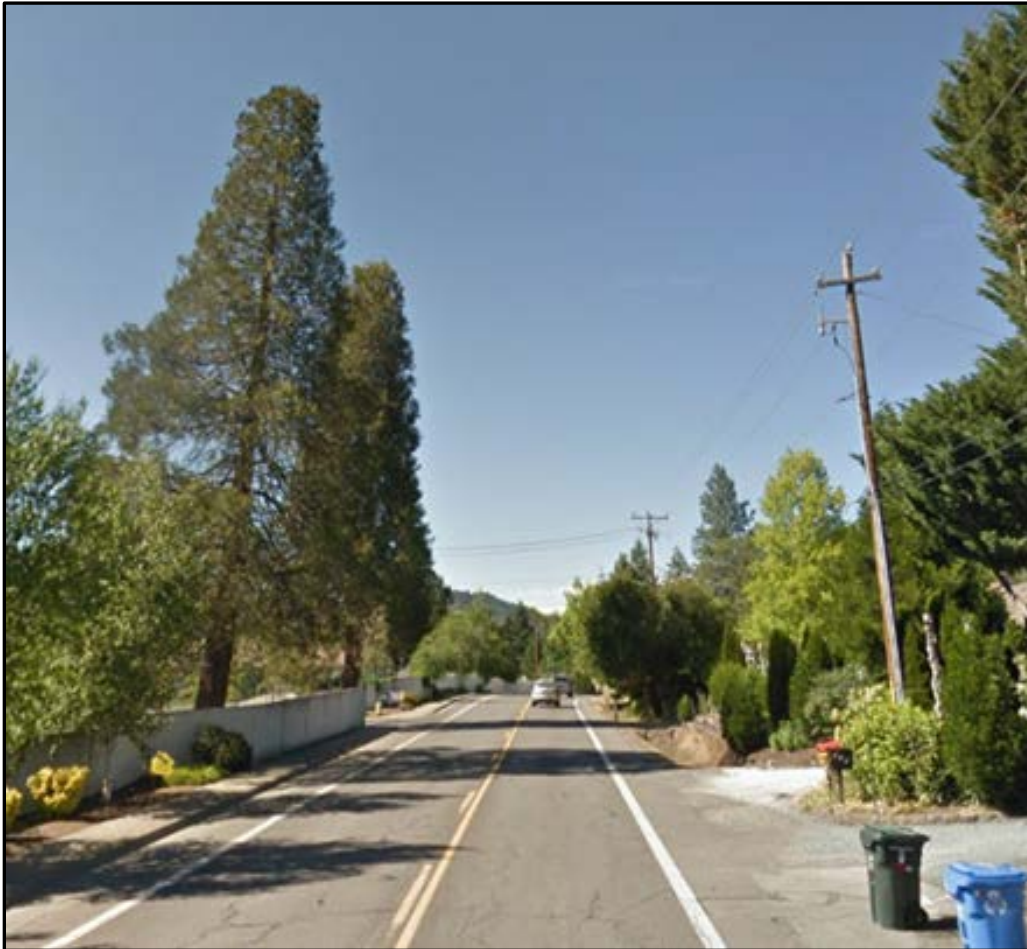
Drivers are not observing and properly yielding to pedestrians at marked crosswalks. Frequently, stops are not happening near schools (P4 other than signalized crossing), Main Street/N River Road (P5 near shopping area), and Broadway (P6 near 1st Street).

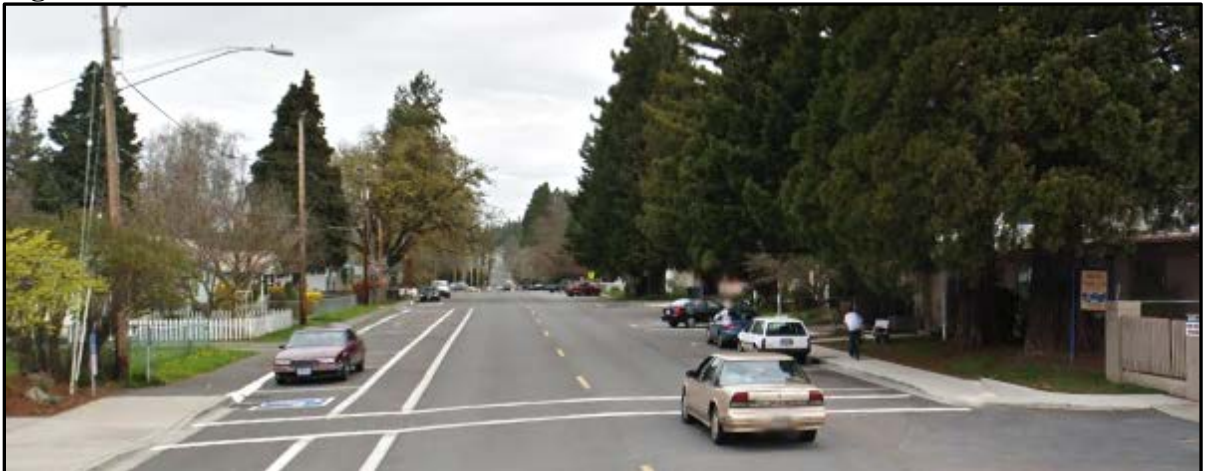
P7 N River Road Curb w/o Sidewalk, Light, and More

North River Road has a sidewalk on the east side from Wards Creek Road to a bit past Classick Drive. There is curbing for much of this distance on the west side, but no sidewalk. There is also a lack of lighting, especially for crosswalks. Note that there is a lack of ADA ramps, including at crosswalks. There is an attraction, Mountain of the Rogue Mt Bike trail that can be used for hikes. This recreational facility should have a defined access with a path or sidewalk into town.

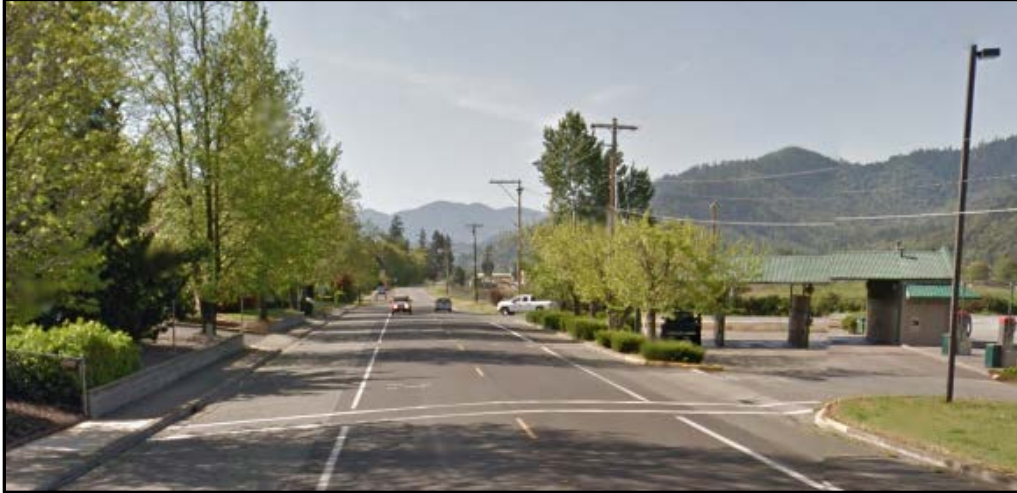
P8 Classick Question

Classick Drive was built by the mill as a truck route. Therefore, it lacks sidewalks on much of it. Some sections have businesses, such as a coffee shop or US Post Office that would attract pedestrians. Some sections of Classick Drive have parking for large trucks. This truck parking area should be defined and planned with alternate paths where it is desired to have the sidewalk closed.

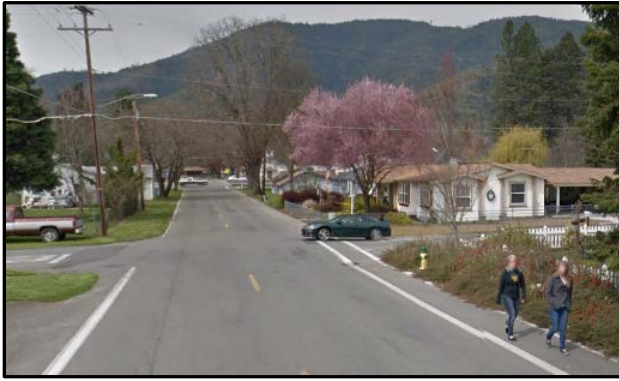
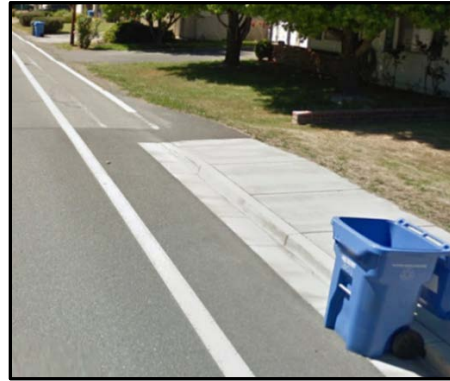
P10 Pine Street Downtown

There are no sidewalks on the north side of Pine Street from Depot Street to East Main Street and south side for a portion of that distance. This leads up to the intersection of Pine Street and Depot Street that needs crosswalks on the stopped legs, not to include the leg that crosses the railroad tracks.

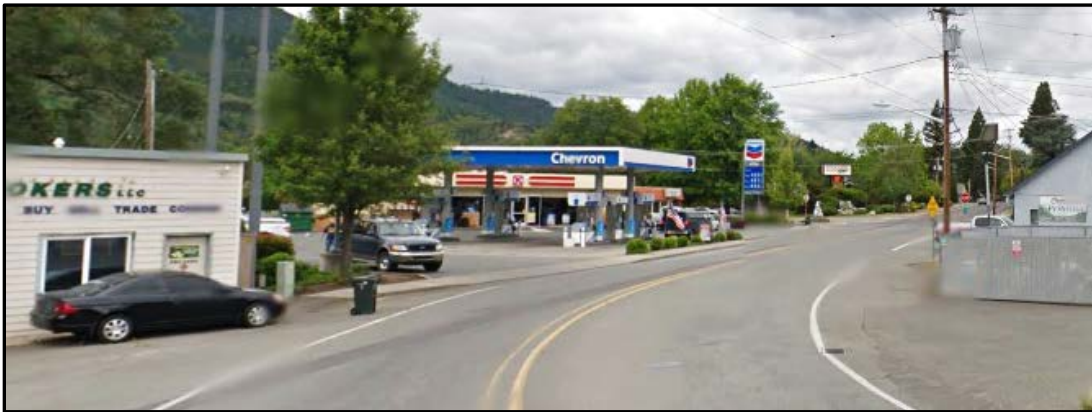
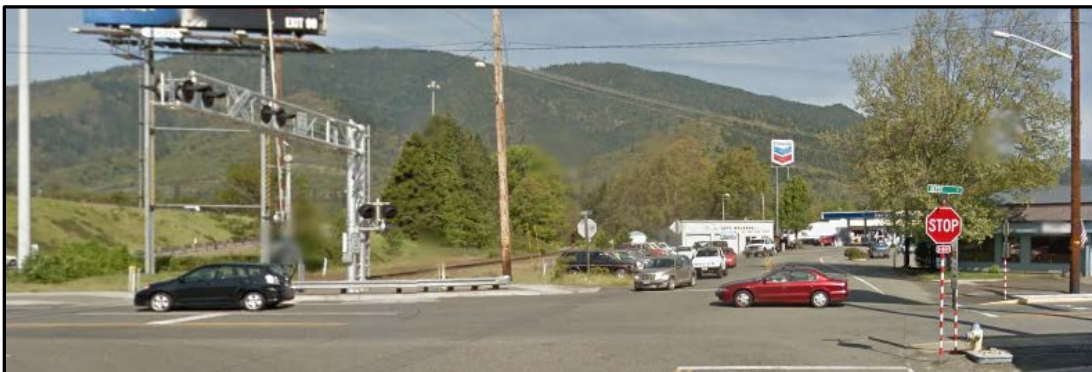
P11 Wards Creek and Surrounding

Wider shoulders are an improvement; there needs to be sidewalks around the mall area. There should be sidewalks from the mall to the assisted living area and mobile homes.

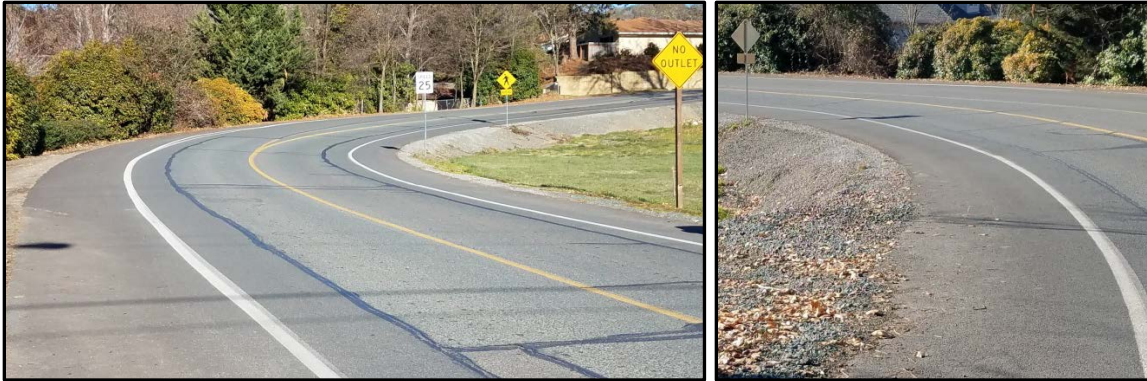
P12 Safe Routes to School

Priority should be given to fixing gaps in sidewalks in the areas surrounding the elementary school. The following map shows where sidewalks are needed. One block away from the elementary school there is a need for sidewalks (all directions but south).

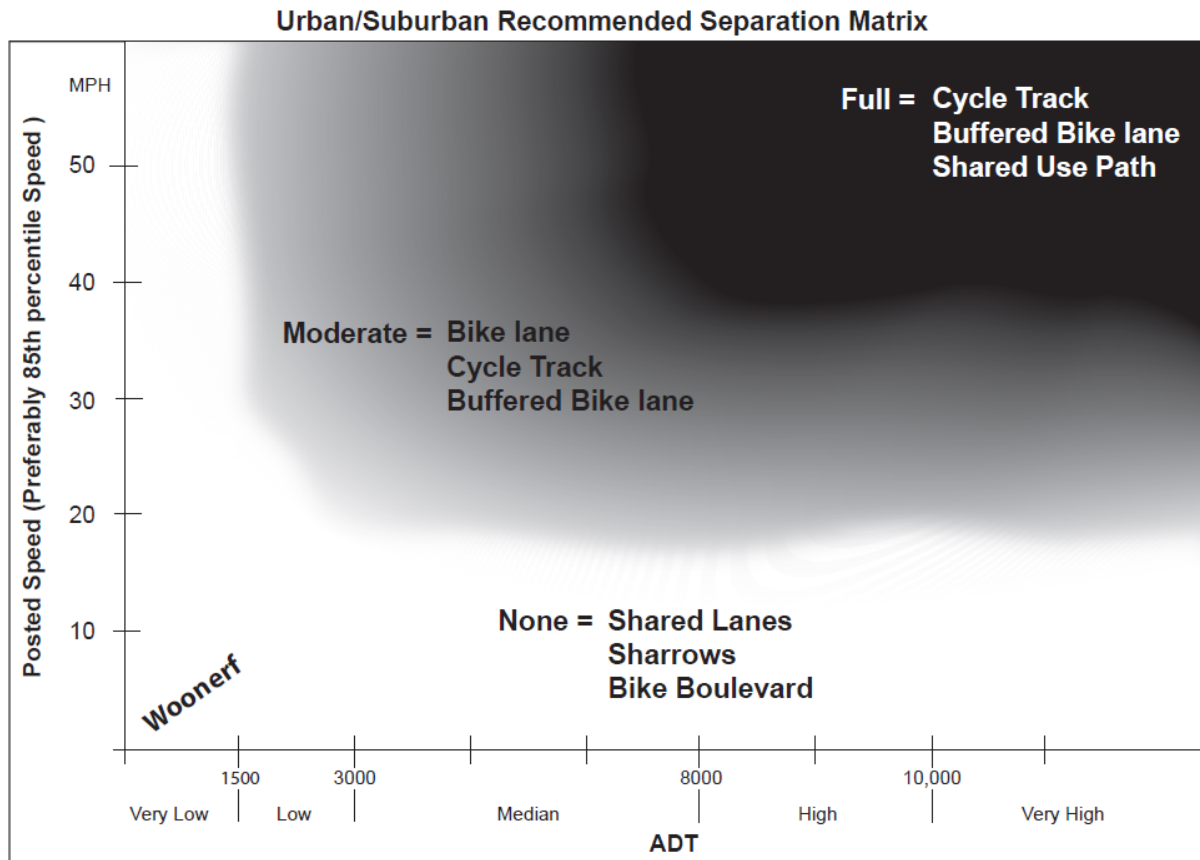
A3 Bicycle Separation Suggestion

From the Oregon Bicycle and Pedestrian Design Guide.
