OREGON DEPARTMENT OF TRANSPORTATION GRANTS PASS INTERCHANGE EXIT 58 ROAD SAFETY AUDIT

N. 6th Street at NW Morgan Lane Mile Point -2.54 to -2.36

January 2013

Grants Pass Interchange Exit 58 Road Safety Audit (RSA)

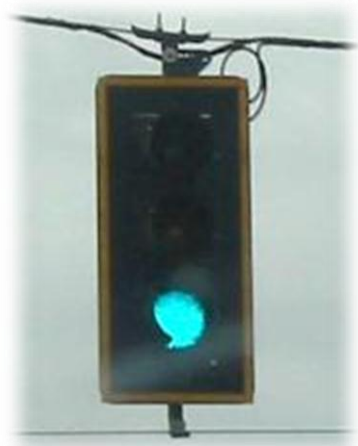
Exhibit 7 Example of reflective striping on signal backplate.

- Install retro-reflective back plates on signal heads to increase visibility of signals.
 - Add 1- to 3-inch-wide reflective strip around backplates (option added to 2009 Manual on Uniform Traffic Control Devices [MUTCD]) – see Exhibit 7 and Exhibit 8
- Review number, size, and location of signal heads and compare to MUTCD and ODOT “Traffic Signal Policy and Guidelines”
- Change signal indications
 - Change the signal indications for the inside lanes of the I-5 southbound ramp and NE Scoville Road to 4-section heads that include green arrows for the right- and left-turns. See Exhibit 9.

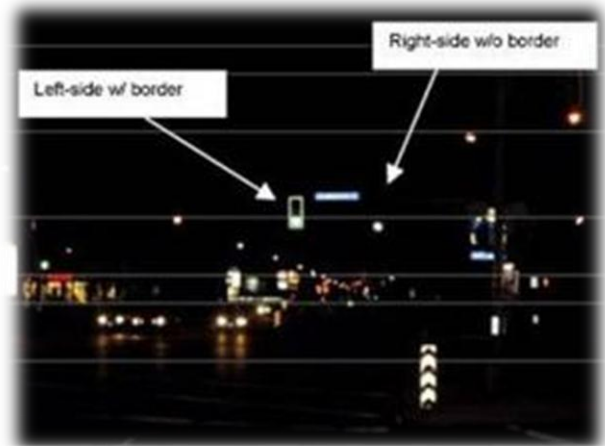
Exhibit 8 Example of signal head visibility with and without reflective backplates.

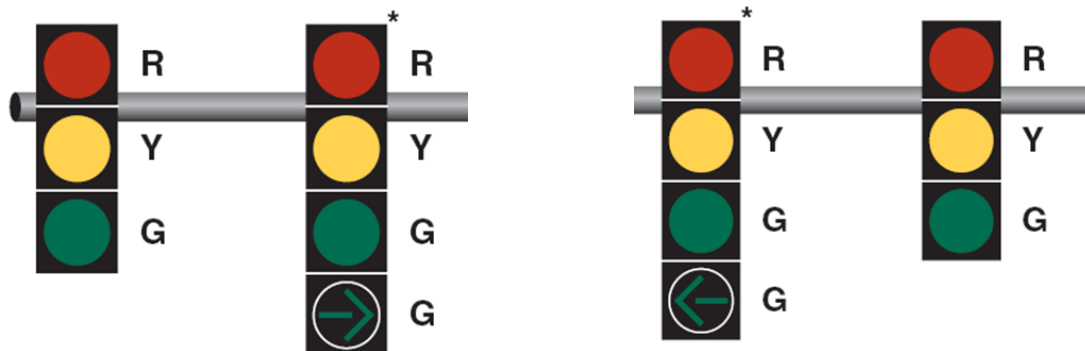
Exhibit 9 Example of 4-section signal heads

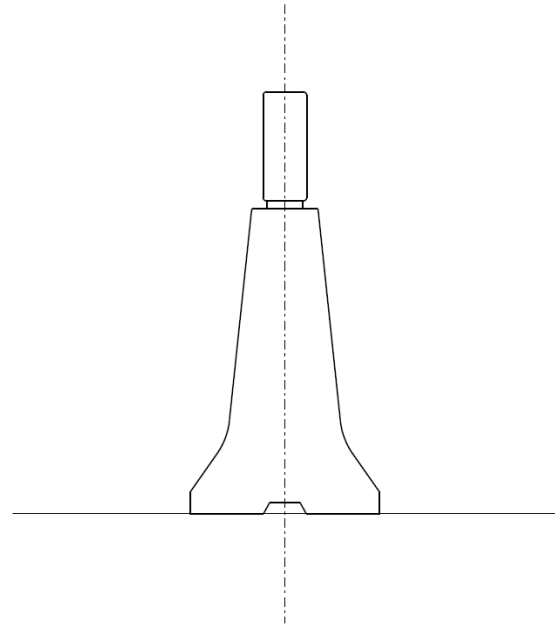
Exhibit 13 Example of 42-inch concrete barrier with glare shield

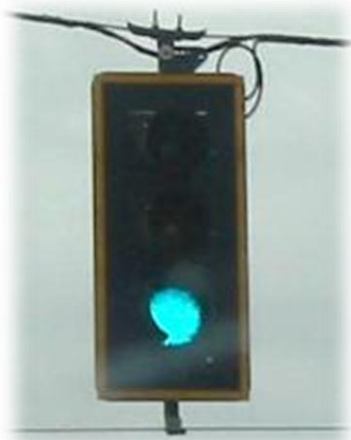
Exhibit 27 Example of reflective striping on signal backplate

- Install retro-reflective back plates on signal heads to increase visibility of signals
 - Add 1- to 3-inch-wide reflective strip around backplates (option added to 2009 Manual on Uniform Traffic Control Devices [MUTCD]; see Exhibit 27).

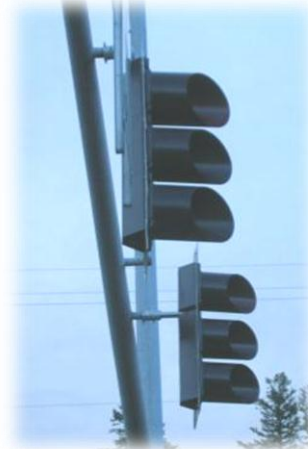
Exhibit 28 Example of extended signal head visors

- Extend the length of signal visors on the southbound approaches' signal heads (see Exhibit 28)
- Update or change the programmable signal heads for the southbound approach (see Exhibit 29)
- Increase eastbound and westbound signal heads to 12-inch lenses
- Reduce distracting signing that takes away from the important right-of-way message provided by the signal heads. The design of traffic signal modifications will require key coordination with signing to ensure that only essential signing is placed on the signal poles and mast arms.

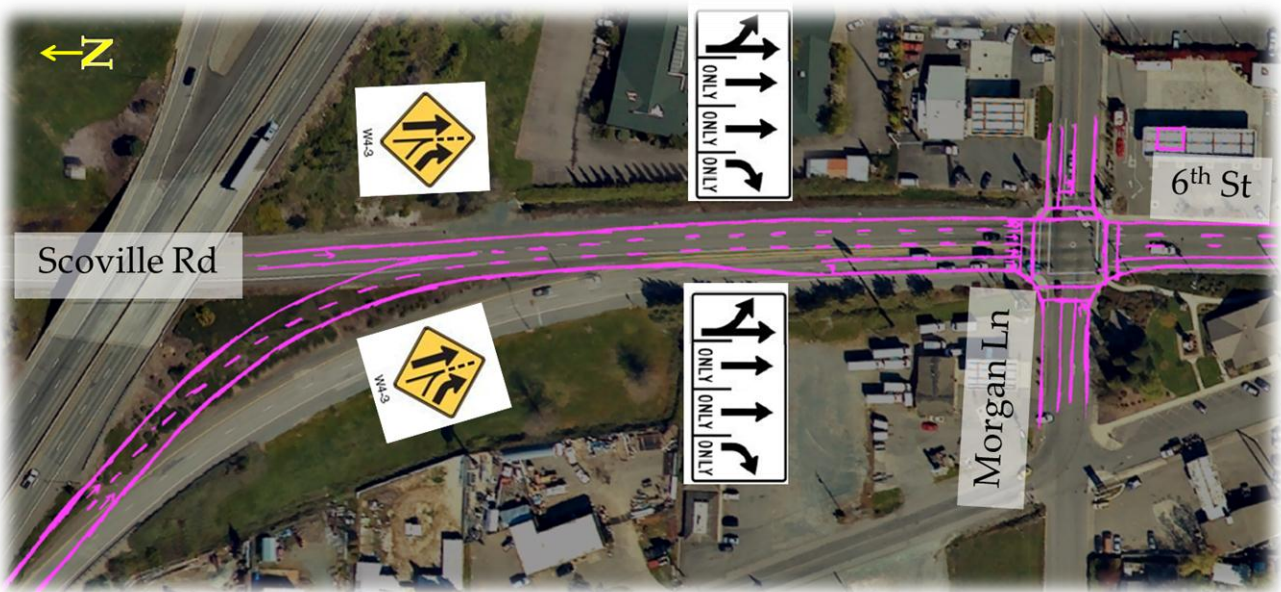
Exhibit 35 Lane use signage – Realign and re-grade off-ramp with re-graded Scoville Road

- Prioritize signage to relay the most important information
 - Regulatory
 - Warning
 - Informational and guide signing
- Considerations (apply to all recommendations):
 - Add lane designation signage prior to intersection (See Exhibit 34 through Exhibit 36)
 - Reduce signage on mast arms
 - Move Oregon Travel Experience (OTE) signs back on off-ramp
 - Combine City of Grants Pass entry and population signs (3 signs into 1)
 - Upgrade sign sheeting to High Intensity Prismatic (HIP)
 - Provide appropriate sign spacing per the MUTCD

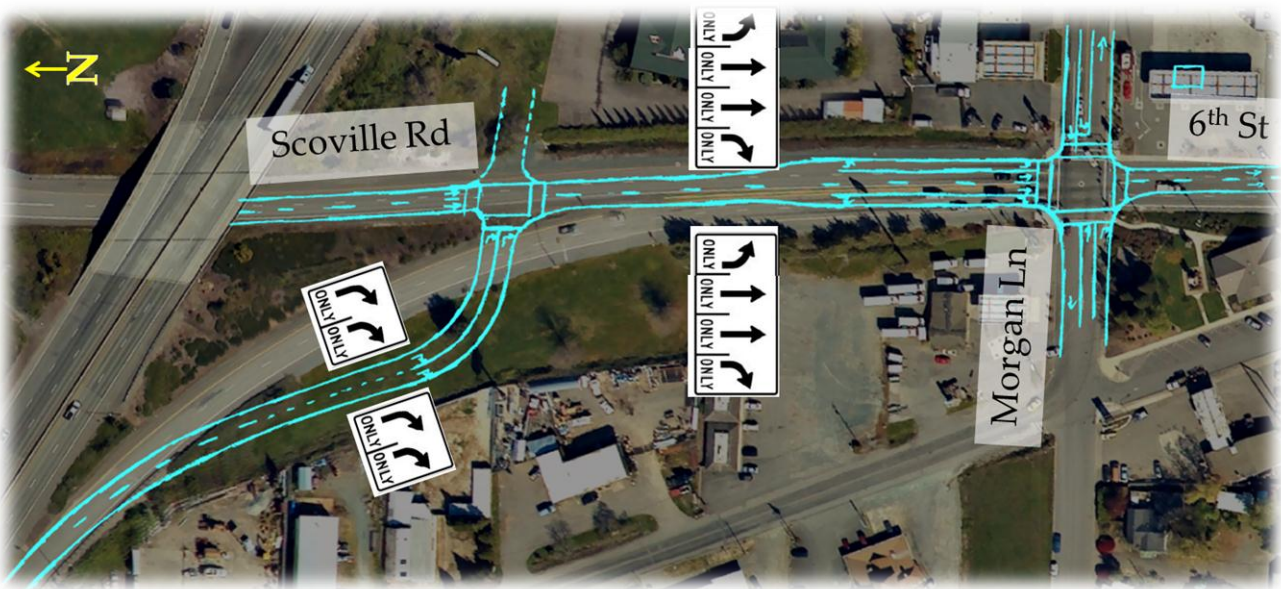
Exhibit 36 Lane use signage – Introduce a new signal and simplify to two 2-phase signals
